Manhole Inspection Summary

Manhole # S37II_024MH

Location Address: **424 PITTMAN PL**

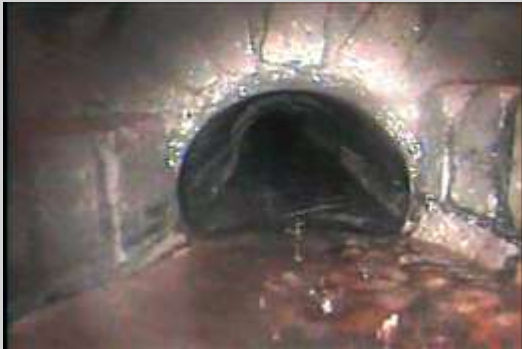
8 in. Circular Gravity Sewer Pipe Out @ 12 O'Clock

Invert Depth: **7.95** (ft.) Flow Characteristics: **Fast**

Deposits: ☒ None ☐ Mud ☐ Sludge ☐ Debris ☐ Grease

Infiltration: **None** Pipe Seal Cond: **Unknown**

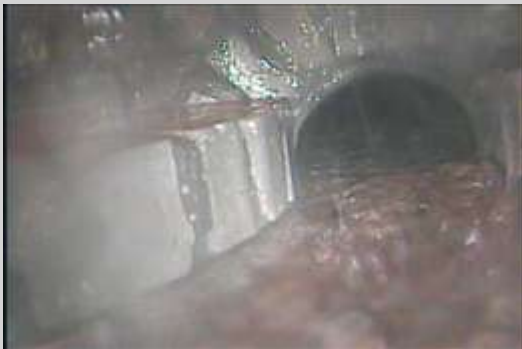
8 in. Circular Gravity Sewer Pipe In @ 3 O'Clock

Infiltration: **None** Pipe Seal Cond: **Unknown**
